DUGWAY PERMIT

ATTACHMENT 11

**HWMU 169
POST-CLOSURE PLAN**

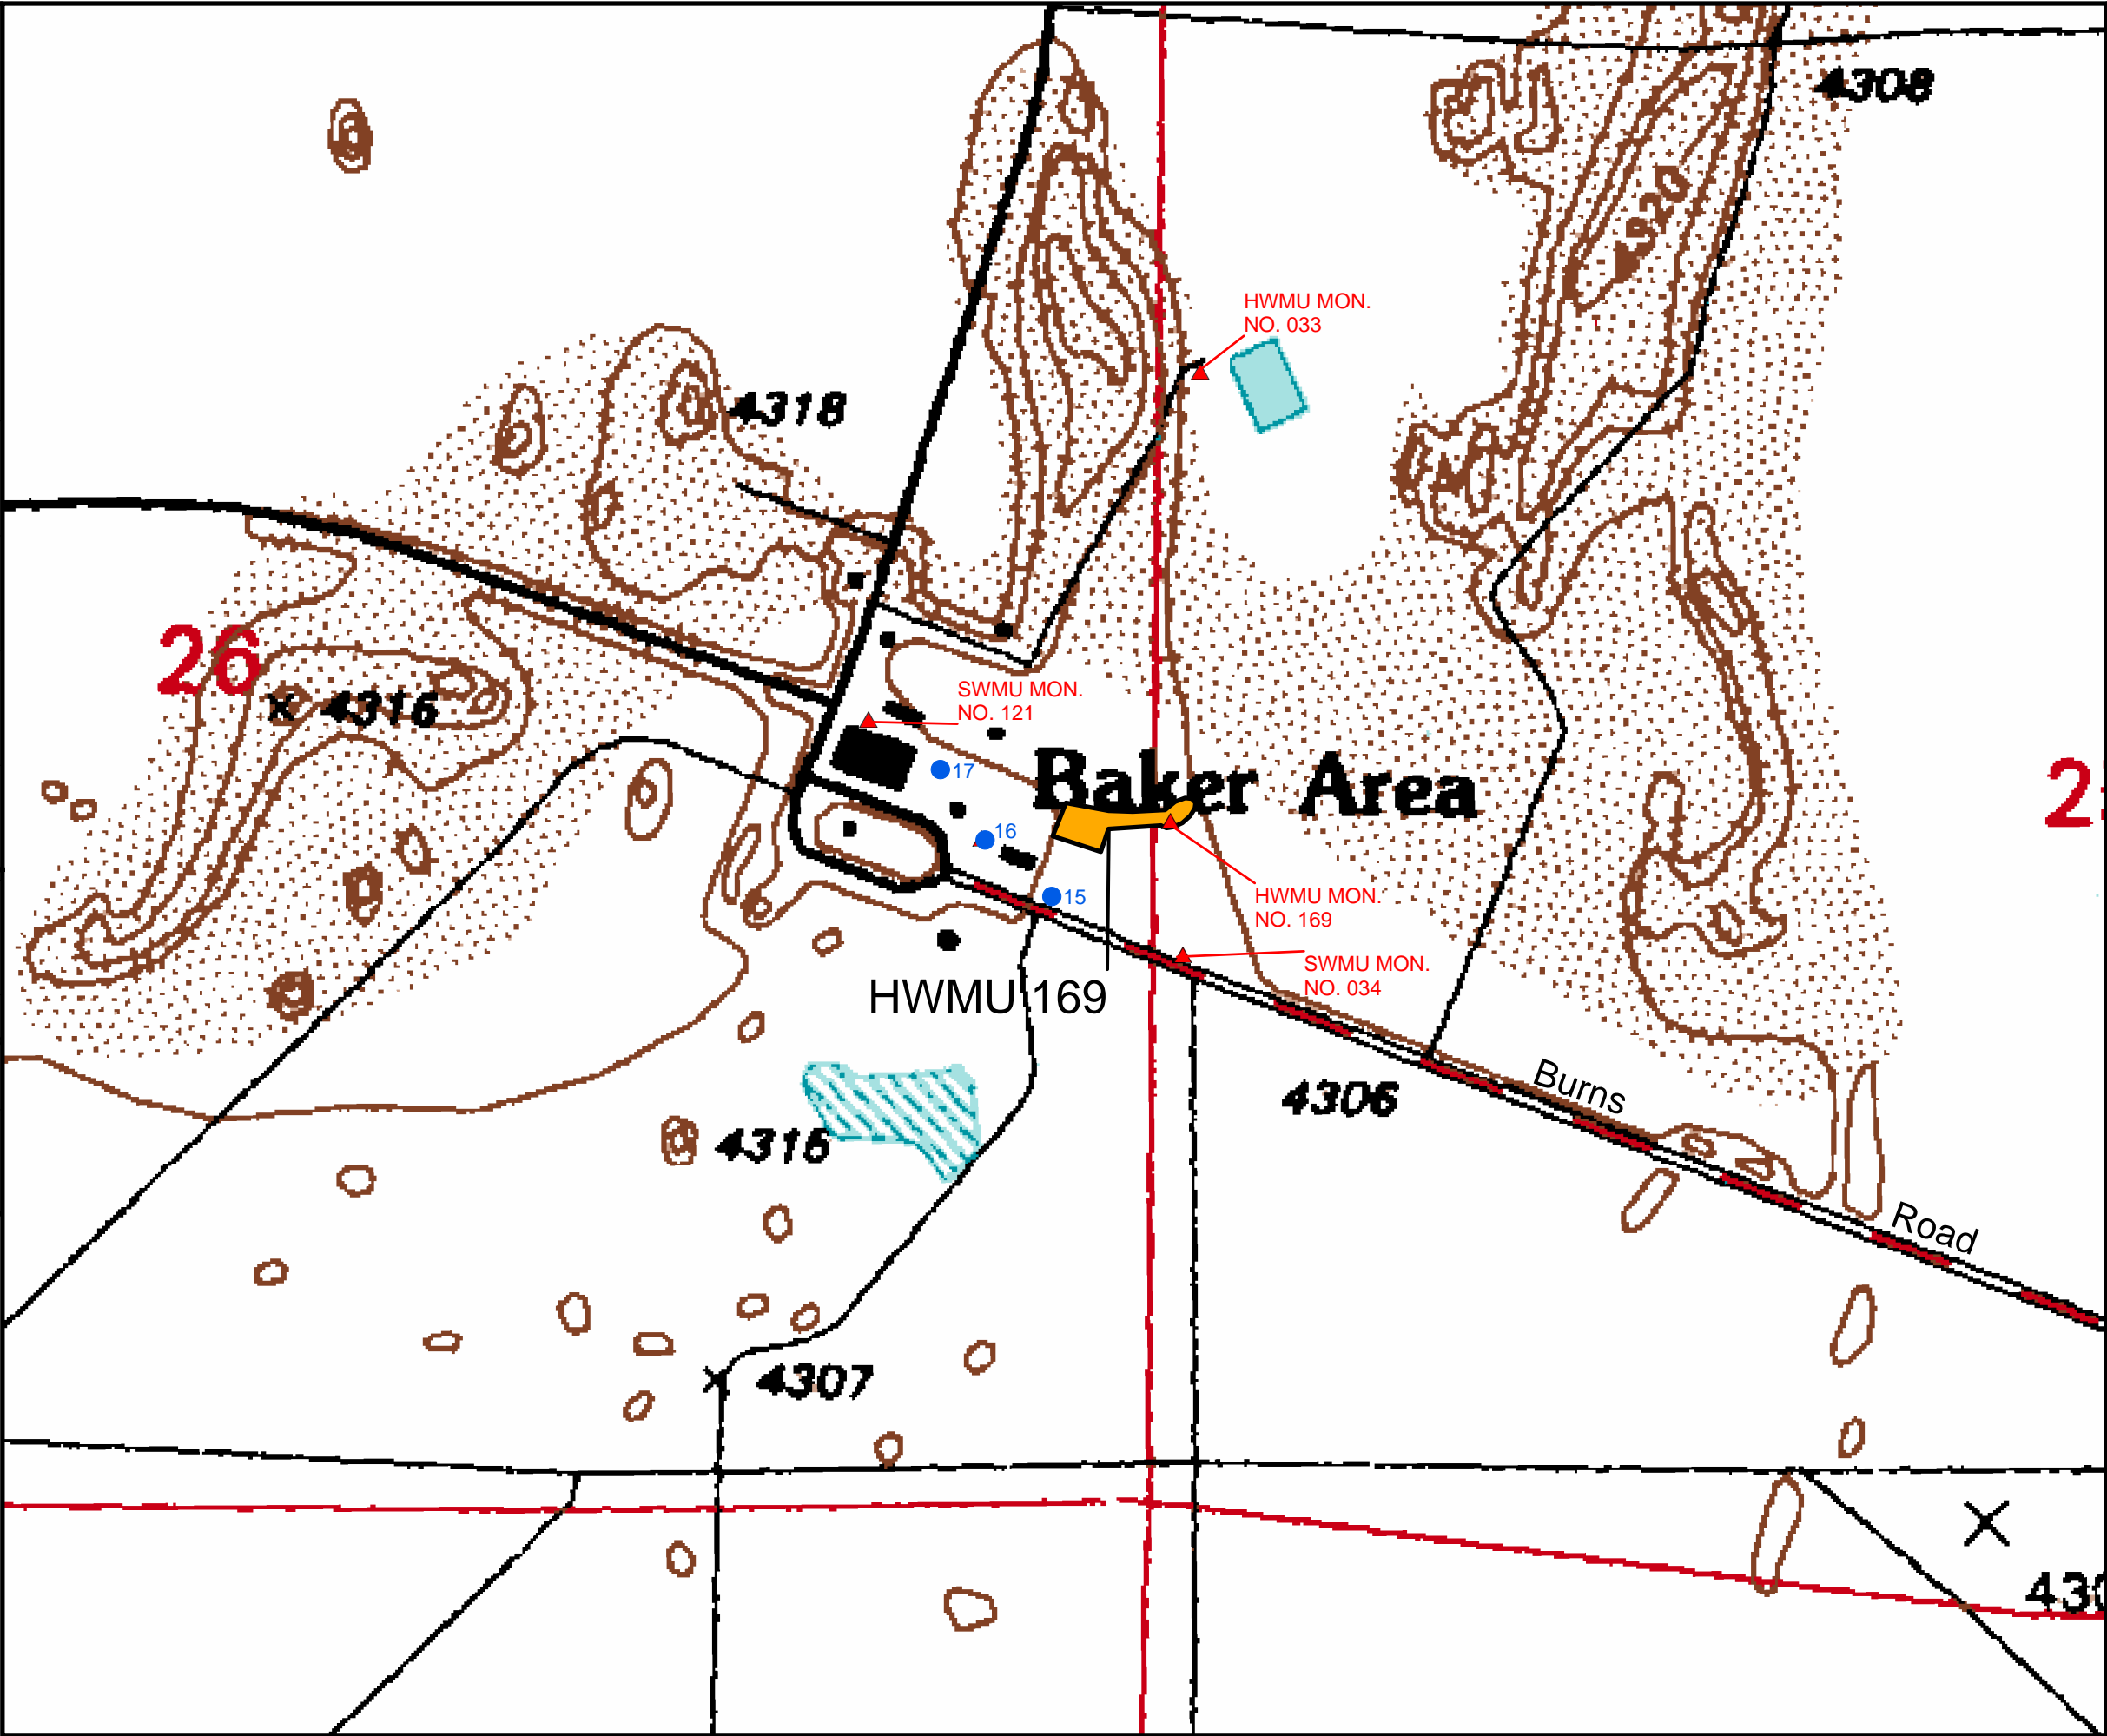
Figure 2
Topographic Map of Baker Area
in the Vicinity of HWMU 169
Dugway Proving Ground
Dugway, Utah

Hazardous Waste Management Unit 169, the Baker Wash Rack, is located 300 feet (ft) north of Burns Road on the east side of the Baker Area (Figure 2). The Baker Area is a developed area that consists of buildings and structures on an elevated asphalt-covered pad that is connected to outlying structures and other portions of DPG by elevated roads (Figure 3). Hazardous Waste Management Unit 169 is located near the following HWMUs and SWMUs at the Baker Area:

Below the shallow water-bearing zone, the subsurface consists primarily of sand with minor interbedded clay to the top of a thick clay aquitard. The top of the clay aquitard is at 192 ft bgs based on boring logs from Water Supply Wells 15, 16, and 17 located in the Baker area (Figure 2). The clay aquitard is correlated across the Dugway Basin (Parsons, 2004) and separates the high TDS waters of the upper water-bearing zone from the underlying potable aquifer. The thickness of the clay aquitard is approximately 50 ft in the Baker area.

40 CFR 270.14(b)(19) UAC R315-3-2.5(b)(19) (v)	Topographic Map A wind rose (i.e., prevailing windspeed and direction)	There are no residential populations in the vicinity of HWMU 169. The closest residential area is English Village (approximately 21 miles away). A wind rose is not deemed necessary for HWMU 169.
40 CFR 270.14(b)(19) UAC R315-3-2.5(b)(19) (vi)	Topographic Map Orientation of Map, North Arrow	Figure 2.
40 CFR 270.14(b)(19) UAC R315-3-2.5(b)(19) (vii)	Topographic Map Legal boundaries of the hazardous waste management facility.	Legal boundaries have not been established at DPG for former HWMUs.
40 CFR 270.14(b)(19) UAC R315-3-2.5(b)(19) (viii)	Topographic Map Access control, fence, gates	Section 3.0 and Figure 2.
40 CFR 270.14(b)(19) UAC R315-3-2.5(b)(19) (ix)	Topographic Map Injection and withdrawal wells	Three water supply wells are located in the vicinity of HWMU 169; Figure 2.
40 CFR 270.14(b)(19) UAC R315-3-2.5(b)(19) (xi)	Topographic Map Barriers for drainage or flood control	There are no flood control structures on or in the vicinity of HWMU 169; Figure 2.

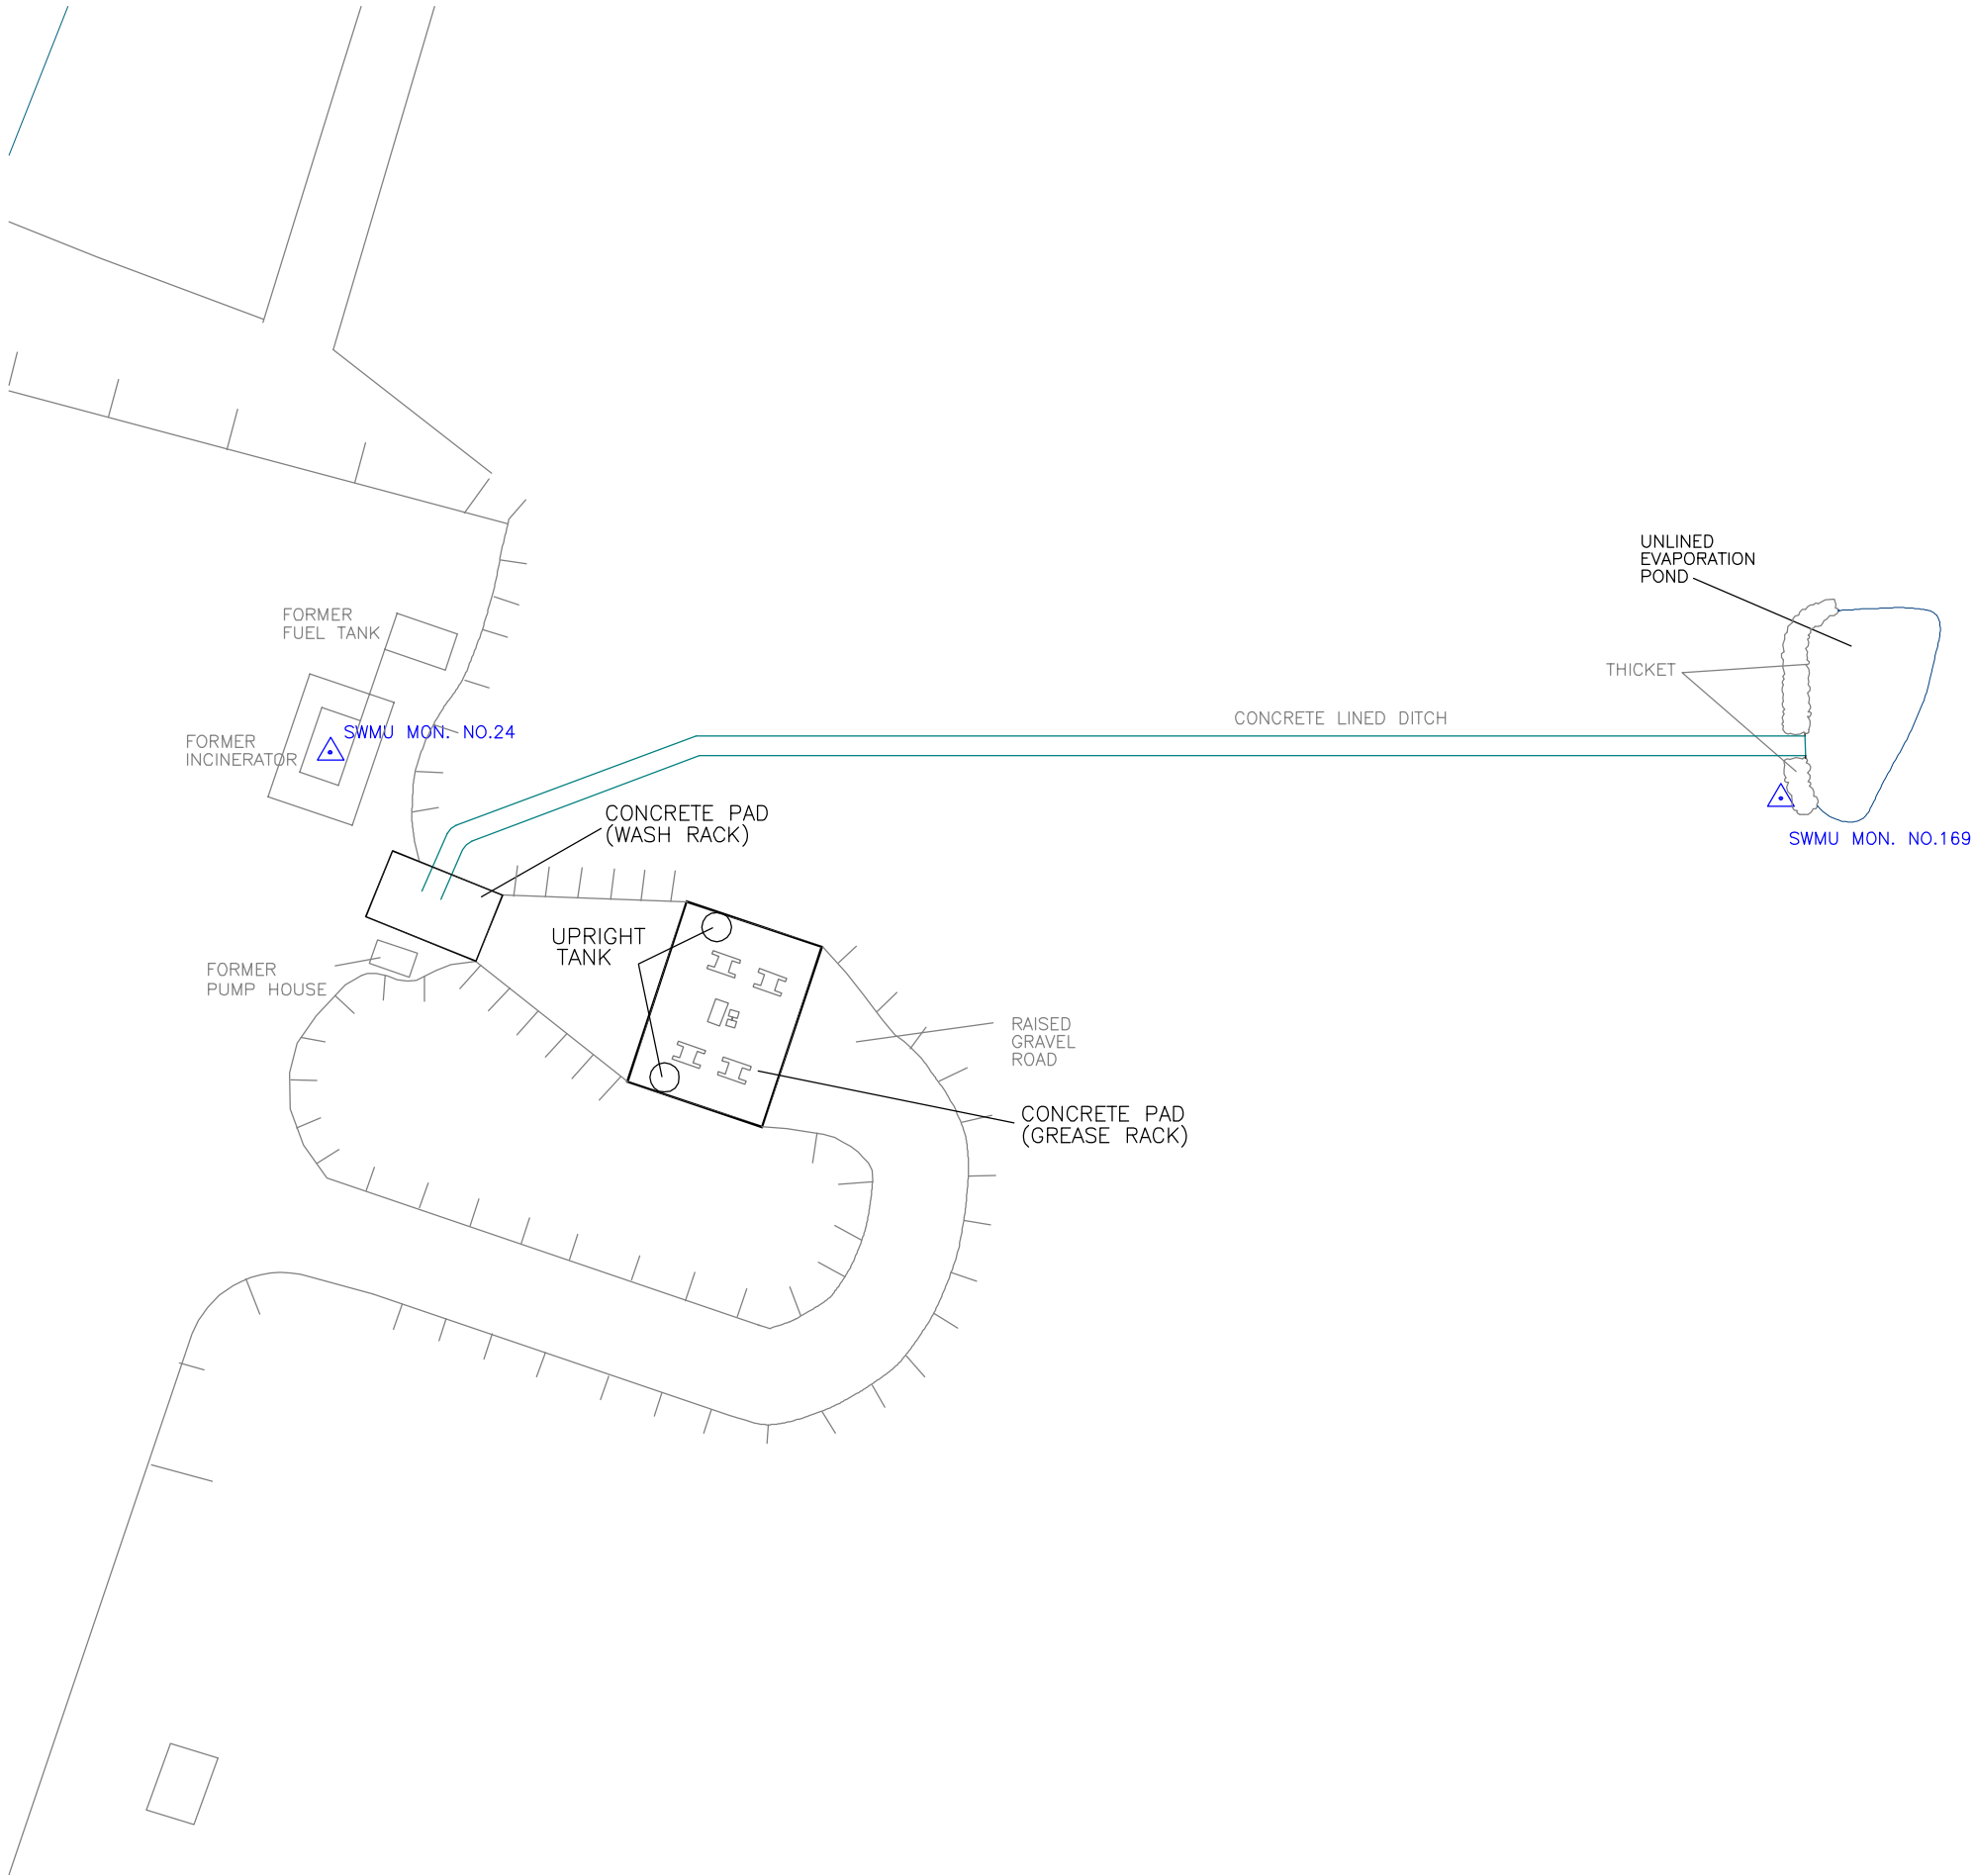
FIGURE 4
HWMU 169
SITE MAP

The Baker Wash Rack consists of two concrete pads, a concrete-lined ditch, and an unlined evaporation pond (Figure 4). The system was designed so that rinse water and other liquid wastes would drain from the pads into the concrete lined ditch and discharge into the unlined evaporation pond. The first concrete pad was used to wash the underside of vehicles using high-pressure water. The water drained into a sump beneath the pad and then into the lined ditch. The larger pad was used as a vehicle hoist and grease rack, containing two adjacent vehicle hoists that rose from two covered compartments. The hoists were operated by separate hydraulic systems. Any liquid that fell into the hoist compartments drained into a vitrified clay pipe and then to the concrete lined ditch. The pads encompass an area of approximately 90 ft by 40 ft. The lined ditch is approximately 300 ft long and 2.5 ft deep. The unlined evaporation pond is surrounded by a 3-ft high earthen berm.
